# Manhole Inspection Summary

Manhole # S25AA2001MH

Insp Date: **10/31/06 12:37 PM**

**Location** Address: **5510 LOMBARDY PL**

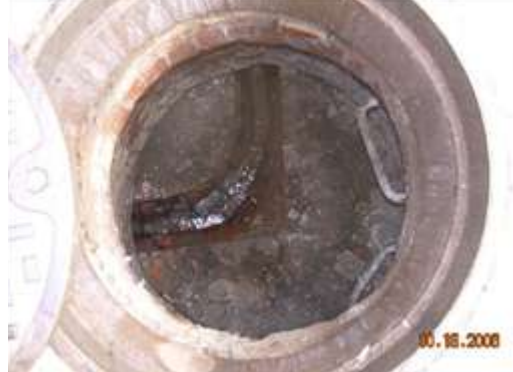
Top View

**Frame** Offset: **0** (in.) Condition: ☐ Sound ☐ Cracked ☒ **Leaks**

**Surcharge** ☒ **Evidence Of Surcharge** Depth: **1** (ft.) ☐ Active Surcharge Present

Frame leaks. Frame offset. Evidence of surcharge - Bench debris.

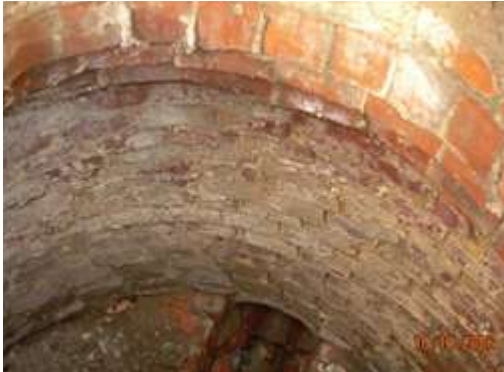
Defect

Condition: ☐ Sound ☐ Cracked ☐ Root Intrusion ☐ Loose Brick ☒ **Deteriorated**

Infiltration: ☐ None ☒ **Joint** ☐ Cracks ☒ **Mortar** ☐ Roots ☐ Wall

Infiltration: ☐ None ☐ Joint ☐ Cracks ☒ **Mortar** ☐ Roots ☐ Wall

Adjustment deterioration and infiltration.  
Barrel infiltration.

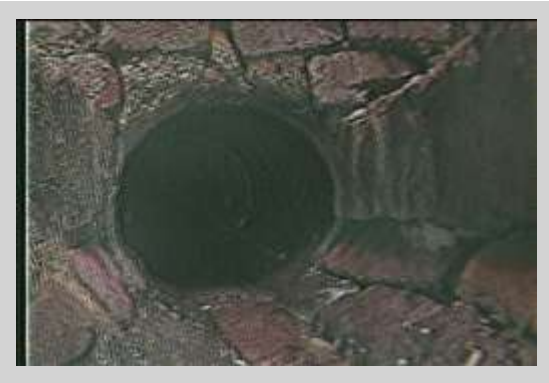
### 8 in. Circular Gravity Sewer Pipe Out @ 12 O'Clock

Barrel deterioration and infiltration. Channel deterioration.

Infiltration: **None** Pipe Seal Cond: **Cracked**

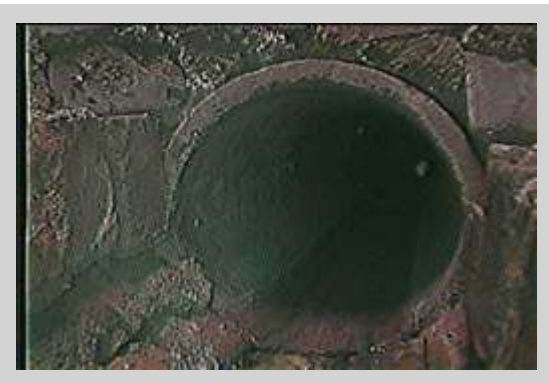
### 8 in. Circular Gravity Sewer Pipe In @ 9 O'Clock

Channel deterioration.
